Application Note

Ether**CAT**[®] Slave Controller Development Products

**Application Note –
Frequently Asked Questions and
Troubleshooting**
ET1100, ET1200, EtherCAT IP Core

Version 1.3
Date: 2017-02-21

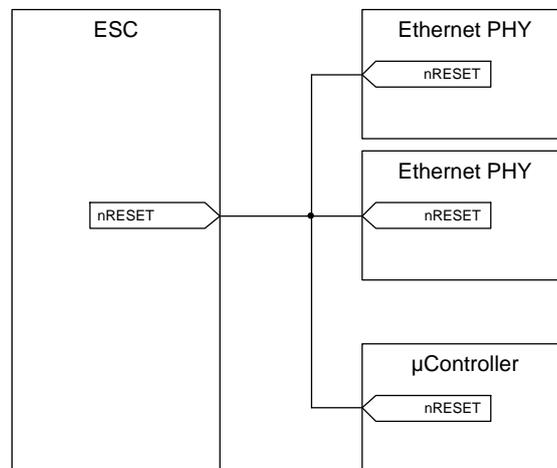
Figure 1: Reset connection principle

A μ Controller attached to the PDI should also be reset by the ESC (e.g. by a soft reset via register 0x0040:0x0041). The intention of the reset register is not to regularly reset any slave, but to get as much parts of a slave into a known state in exceptional situations (strange errors which otherwise require a power-cycle).

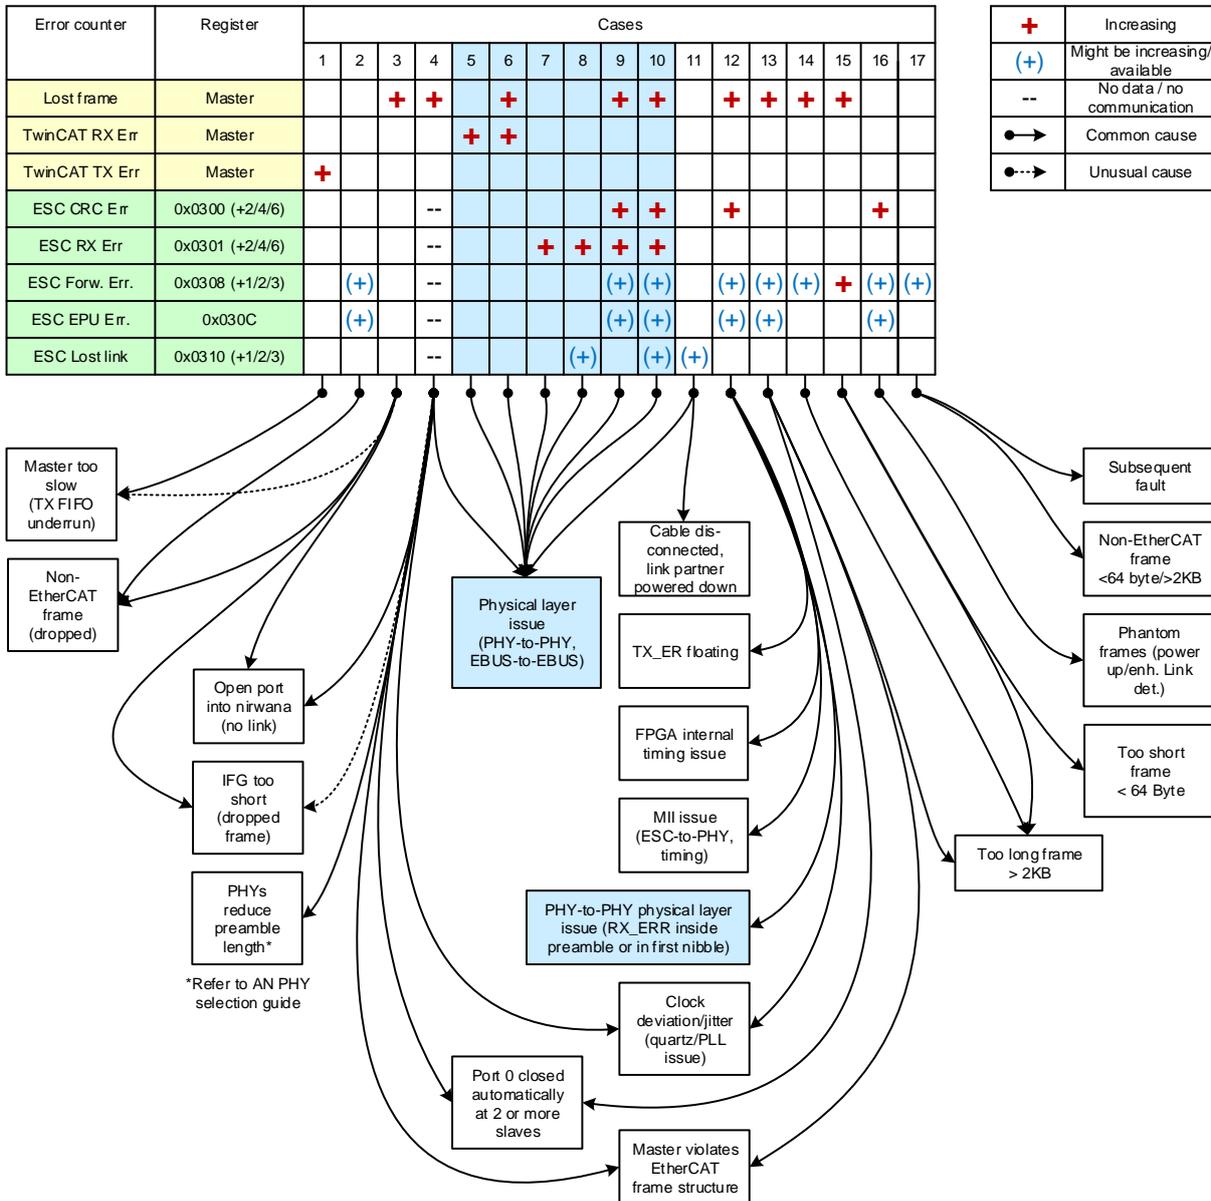
Figure 2: Error counters interpretation guide

The following diagram can be used to identify possible error causes. At first, find out which error counters are increasing in your network (or device), and at the master. Compare this with each of the cases shown in the main table of Figure 2 and find the most similar case. Follow the arrows at the bottom of each column to the possible error causes. Use Table 1 for comments and error localization.

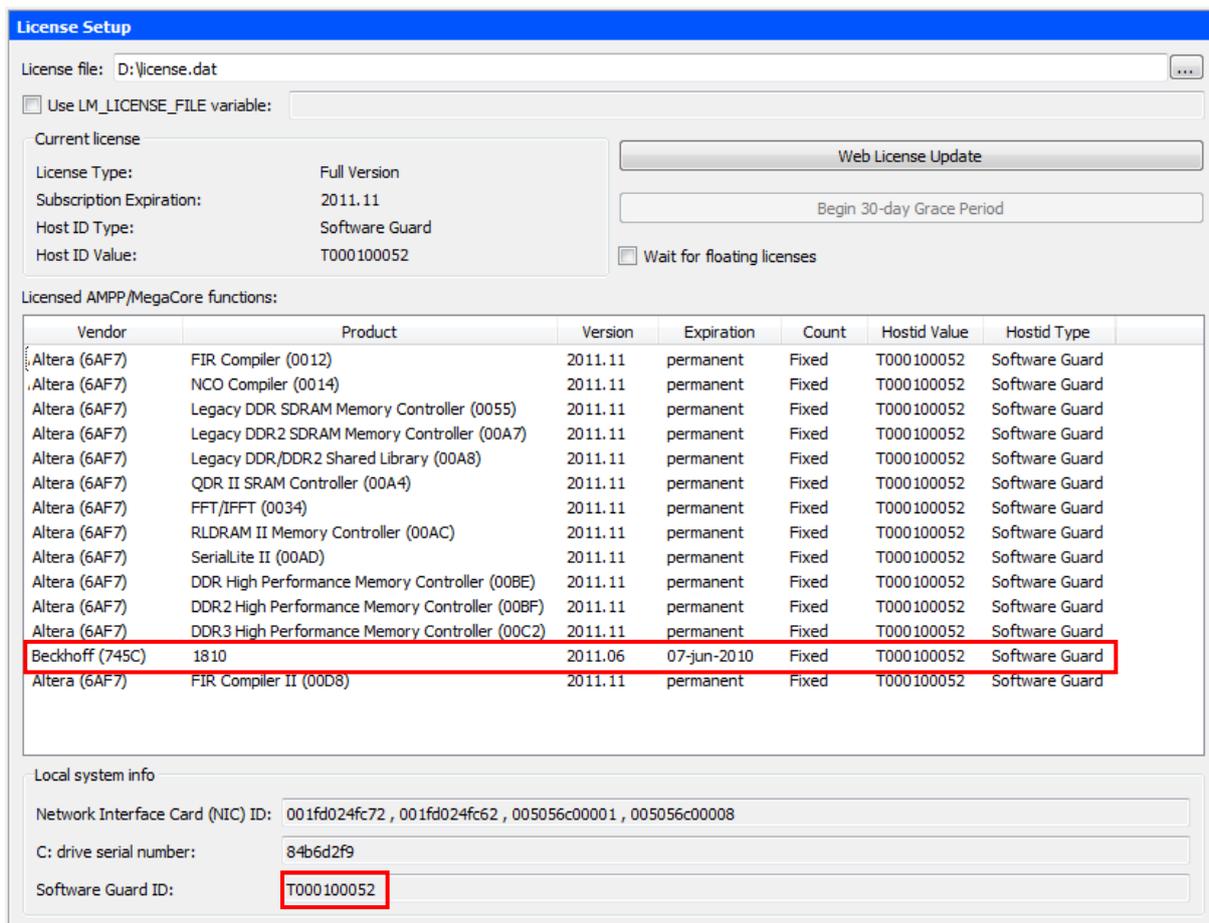
Figure 3: Example license

The EtherCAT IP Core license has Vendor “Beckhoff (745C)”, and Product “1810”. Full license and OpenCore Plus license cannot be distinguished in this window, only during compilation.

1. The version column states the latest release month of an EtherCAT IP Core for which the license is valid. In the example, the license is valid as long as the release month of the IP Core is June 2011 or earlier.
2. The Expiration column shows the date when the license expires. The example license is valid until 2011/06/07. This is the latest date at which you can synthesize the IP Core with this license.
3. The Count column is basically for floating licenses¹ (number of seats). If the value is “Fixed”, you have a node-locked license with one seat.

You can check if your license is valid by invoking Intel Quartus II, menu Tools – License Setup...

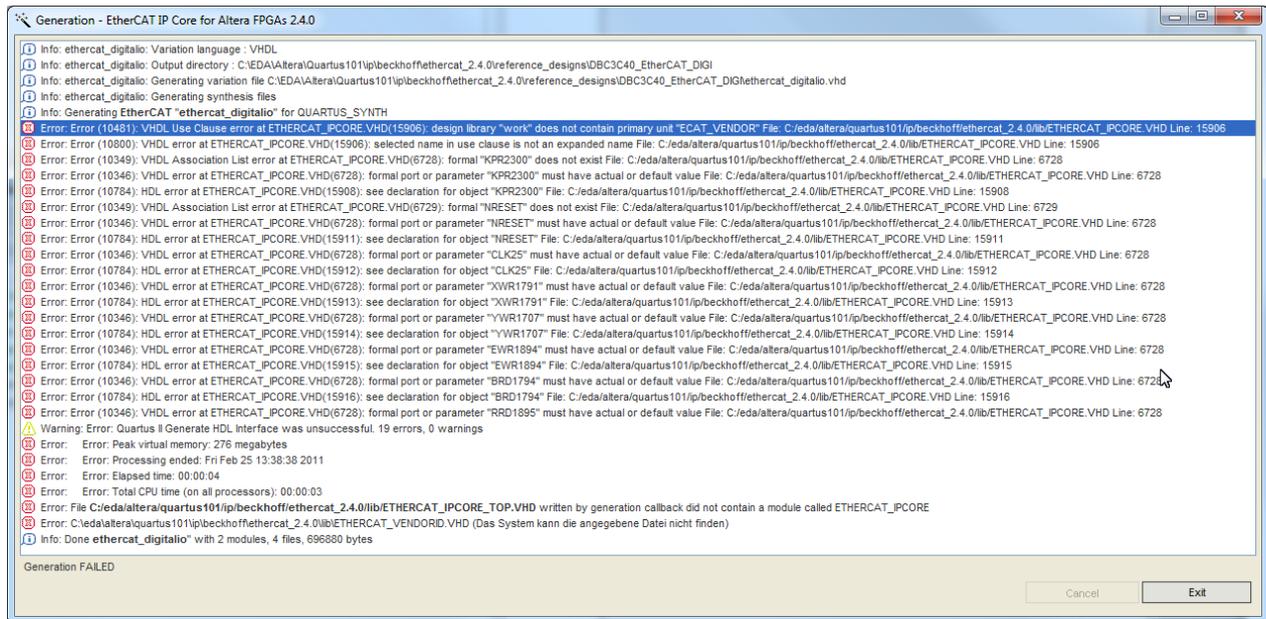
Figure 6: MegaWizard generation issue

Error: Error (10481): VHDL Use Clause error at ETHERCAT_IPCORE.VHD(15906): design library "work" does not contain primary unit "ECAT_VENDOR" File: C:/altera/quartus101/ip/beckhoff/ethercat_2.4.0/lib/ETHERCAT_IPCORE.VHD Line: 15906

If the vendor ID package is missing in the installation folder (e.g., because it was not installed/found during installation), it has to be added manually to the installation folder. Refer to the EtherCAT IP Core datasheet for instructions. Regenerate the EtherCAT IP Core afterwards.

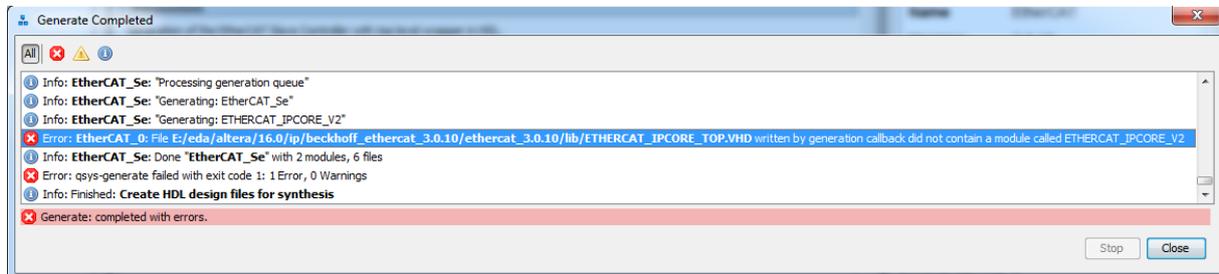
Figure 7: MegaWizard generation issue

Error: EtherCAT_0: File ETHERCAT_IPCORE_TOP.VHD written by generation callback did not contain a module called ETHERCAT_IPCORE_V2

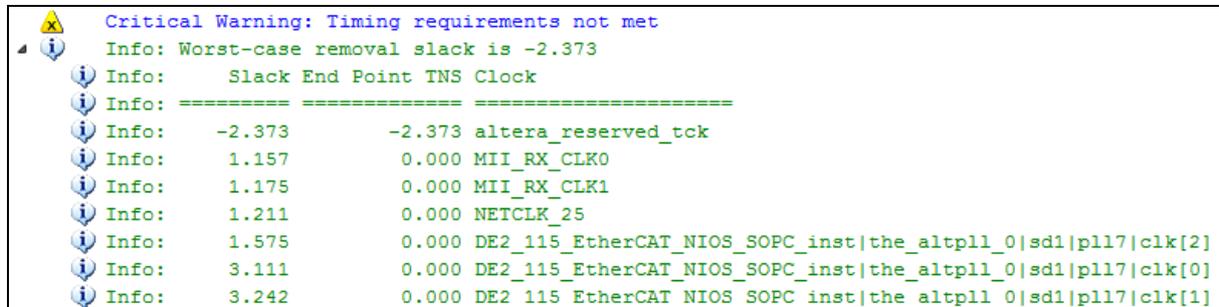
4.2.7.1 OpenCore Plus logic does not achieve timing (altera_reserved_tck)

Sometimes timing requirements are not met with OpenCore Plus. Experience shows that timing violations related to the clock altera_reserved_tck can be ignored. They do not occur with the full version.

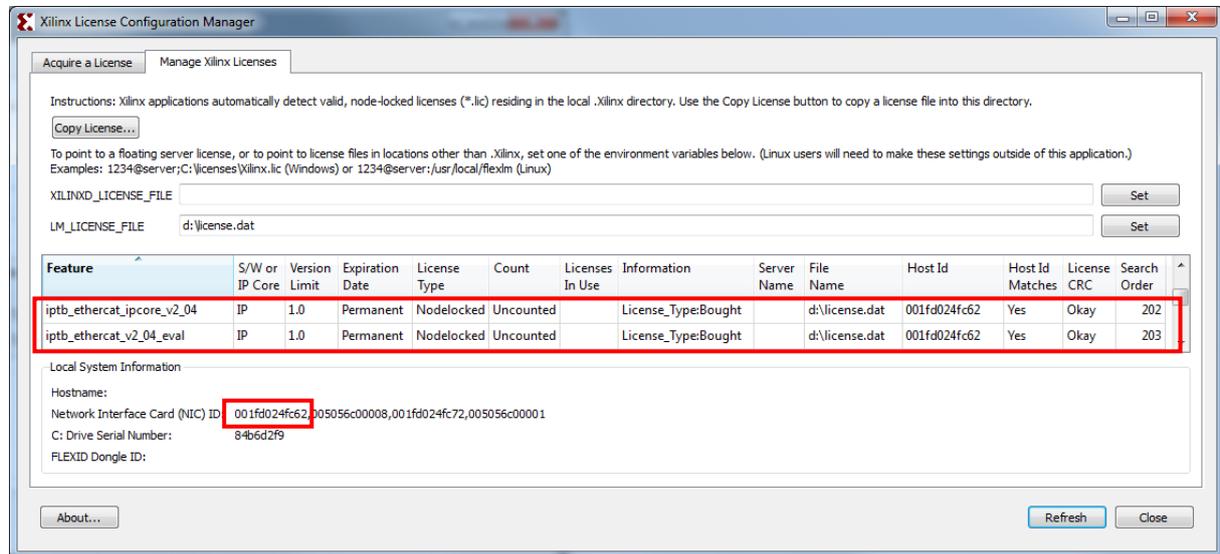
Figure 14: Example license

- The EtherCAT IP Core license has one of the following features:
 - iptb_ethercat_ipcore_v2_04 for the full version (IP Core Version 2.04a-z)
 - iptb_ethercat_v2_04_eval for the evaluation version (IP Core Version 2.04a-z)

For floating licenses², the Ethernet MAC ID must belong to the MAC IDs of the license server.
- The column “Host Id Matches” says “Yes” if the MAC ID was found, otherwise the value is “No”.
- The “License CRC” column shows the result of the license check
- The “Search Order” enumerates all the licenses.

You can check if your license is valid by invoking Xilinx Vivado or ISE, menu Help – Manage License...

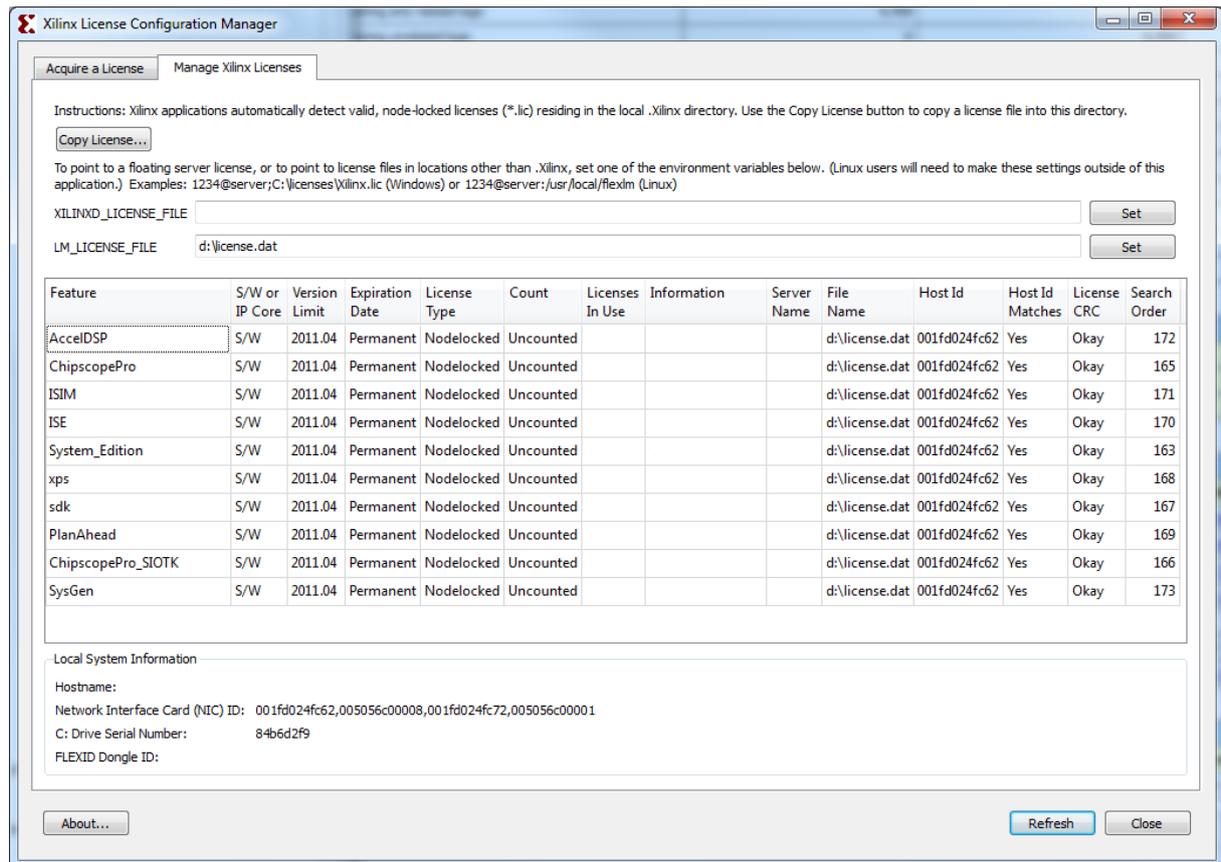
Figure 15: License Configuration Manager: No license available (expecting *iptb_ethercat_...*)

This error occurs if either no valid license was found, or if the type of the license file (full, evaluation) is not the same as the EtherCAT IP Core. The error message shows which license is required by the IP Core (highlighted).

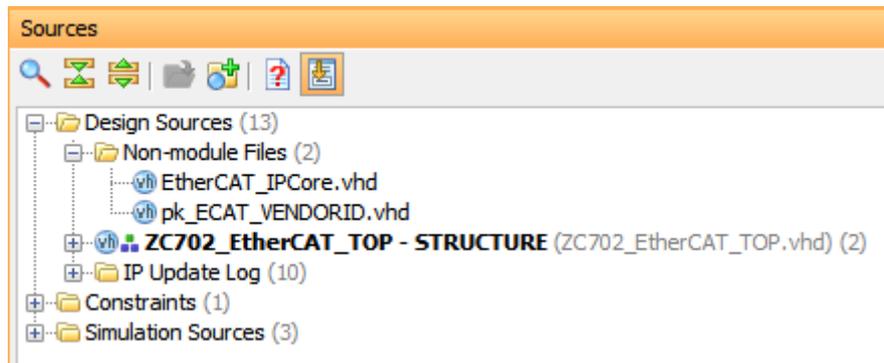
Figure 16: Non-module Files if RSA decryption keys are missing

Vivado cannot decrypt the EtherCAT IP Core sources if the RSA decryption keys are missing. The files are listed as Non-module Files, and they cannot be decrypted/opened:

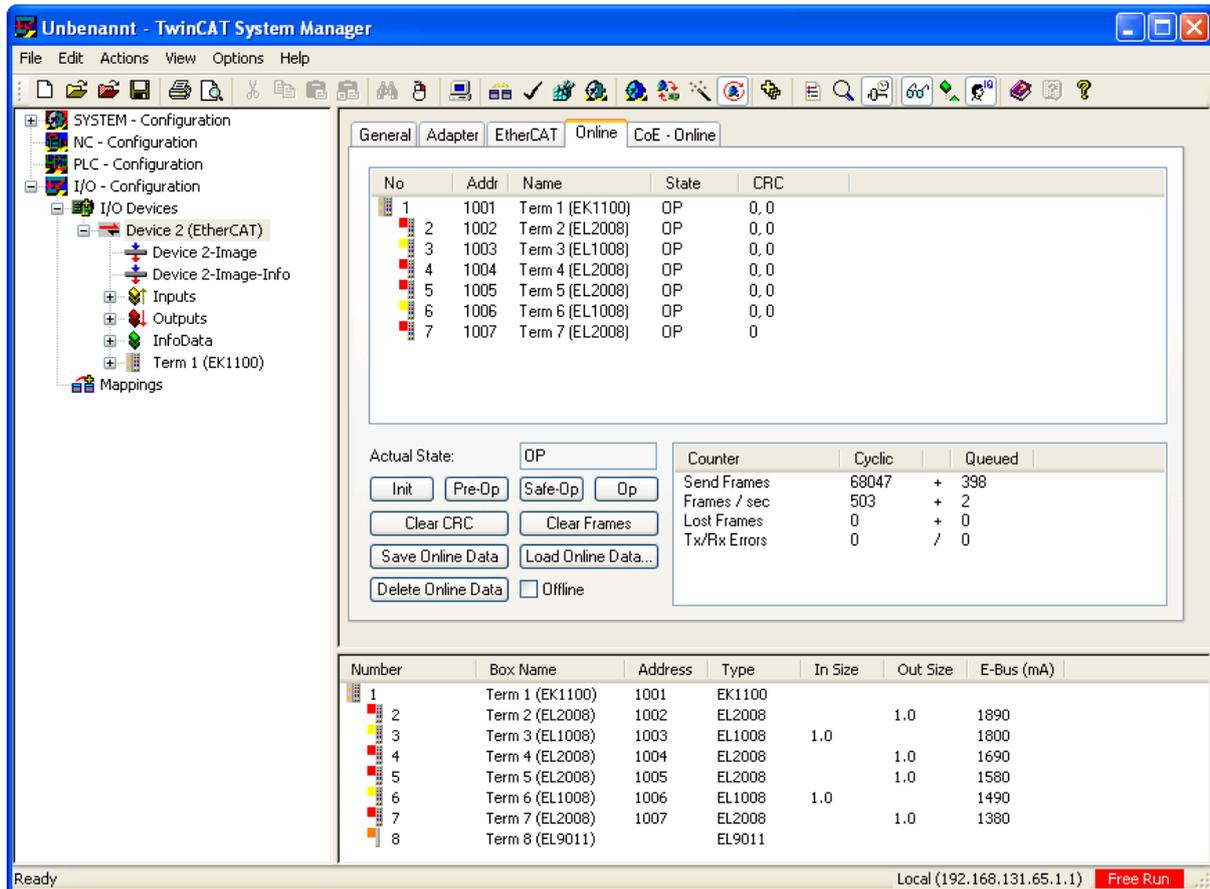
Figure 17: TwinCAT logging CRC error counters

By default, TwinCAT reads out the ESC error counter registers 0x0300/0x0302/0x0304/0x0306 (CRC error port 0-3) and clears them. The results are accumulated in software and displayed in the CRC column for each port of the ESC (separated by commas).

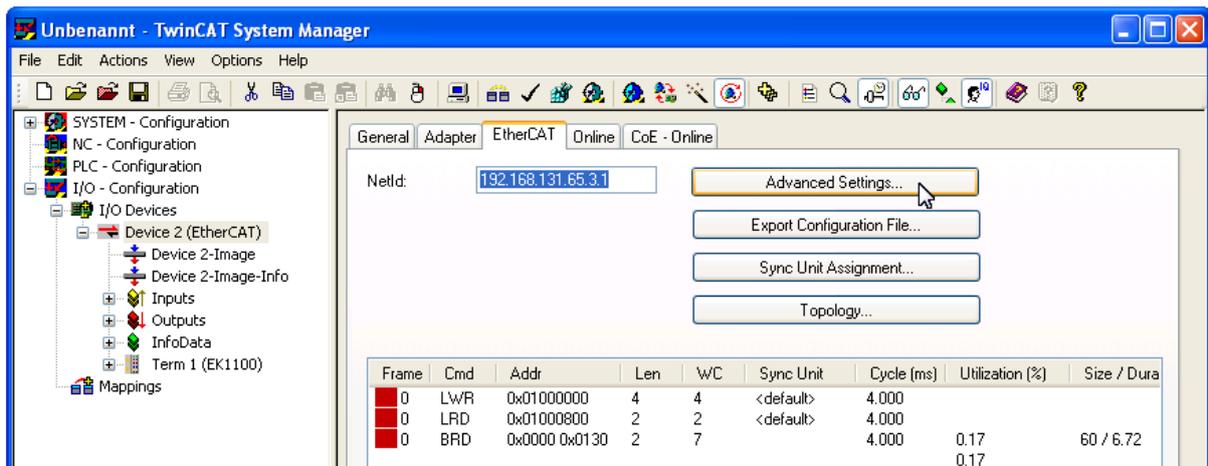
Figure 18: Go to EtherCAT Advanced Settings

1. Go to the “EtherCAT” tab and open “Advanced Settings...”:

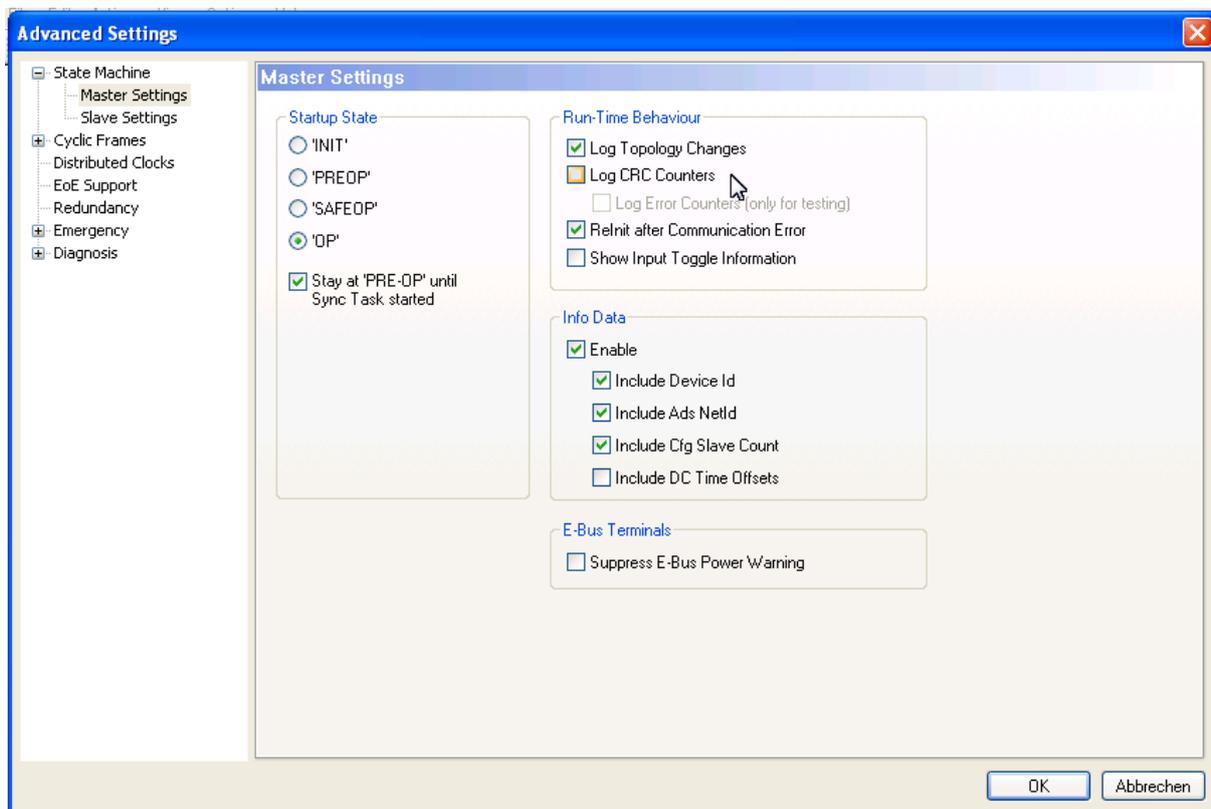
Figure 19: Unselect CRC Counter logging

2. Unselect “Log CRC Counters” and press OK.

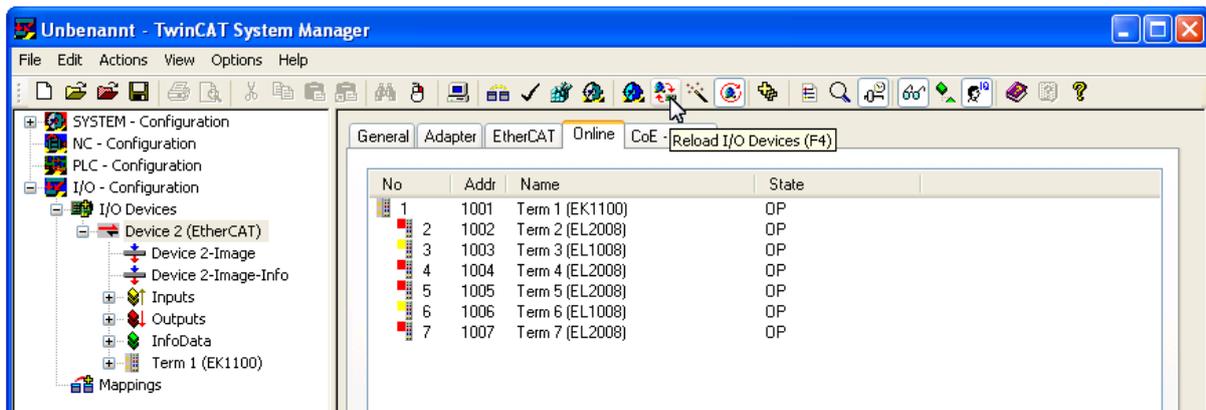
Figure 20: Reload I/O Devices (F4) after disabling CRC logging

- Although the CRC column is not visible anymore, TwinCAT still reads out and clears the CRC error counter registers. Activate the new settings by reloading I/O devices (press F4 or use the button).

It is very important to reload I/O devices (F4) after disabling “Log CRC Counters”, otherwise the error counters will still be cleared automatically by TwinCAT.

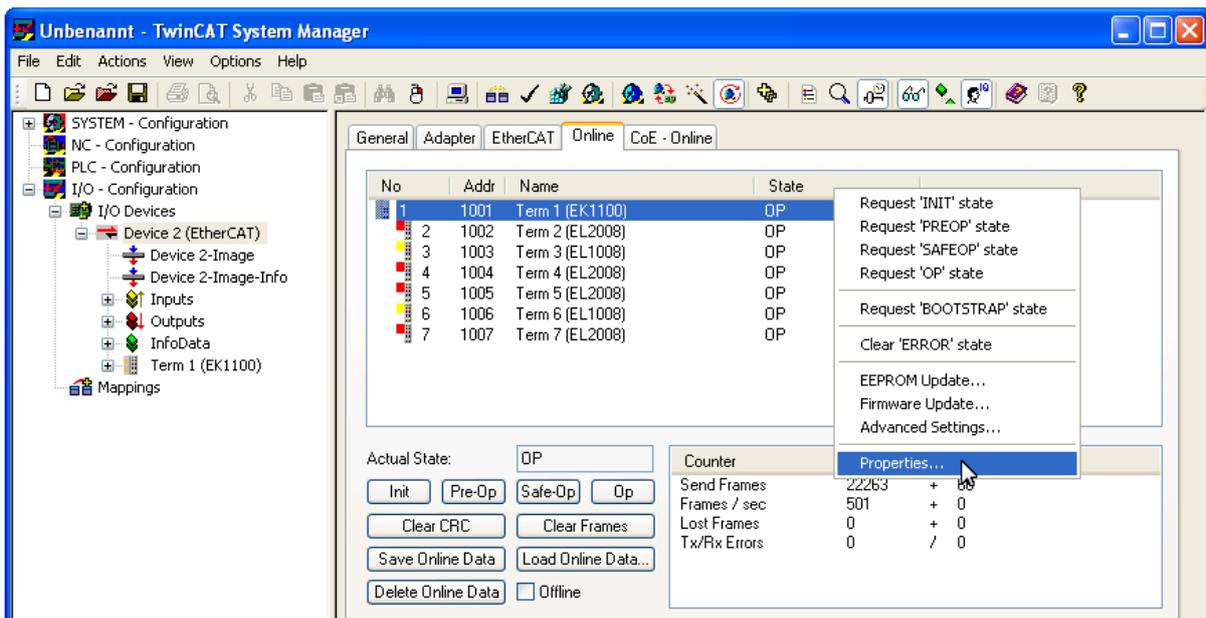
Figure 21: Online view properties

- Now you can add the error counters to the online view. Right-click into the Online view area and select “Properties...”

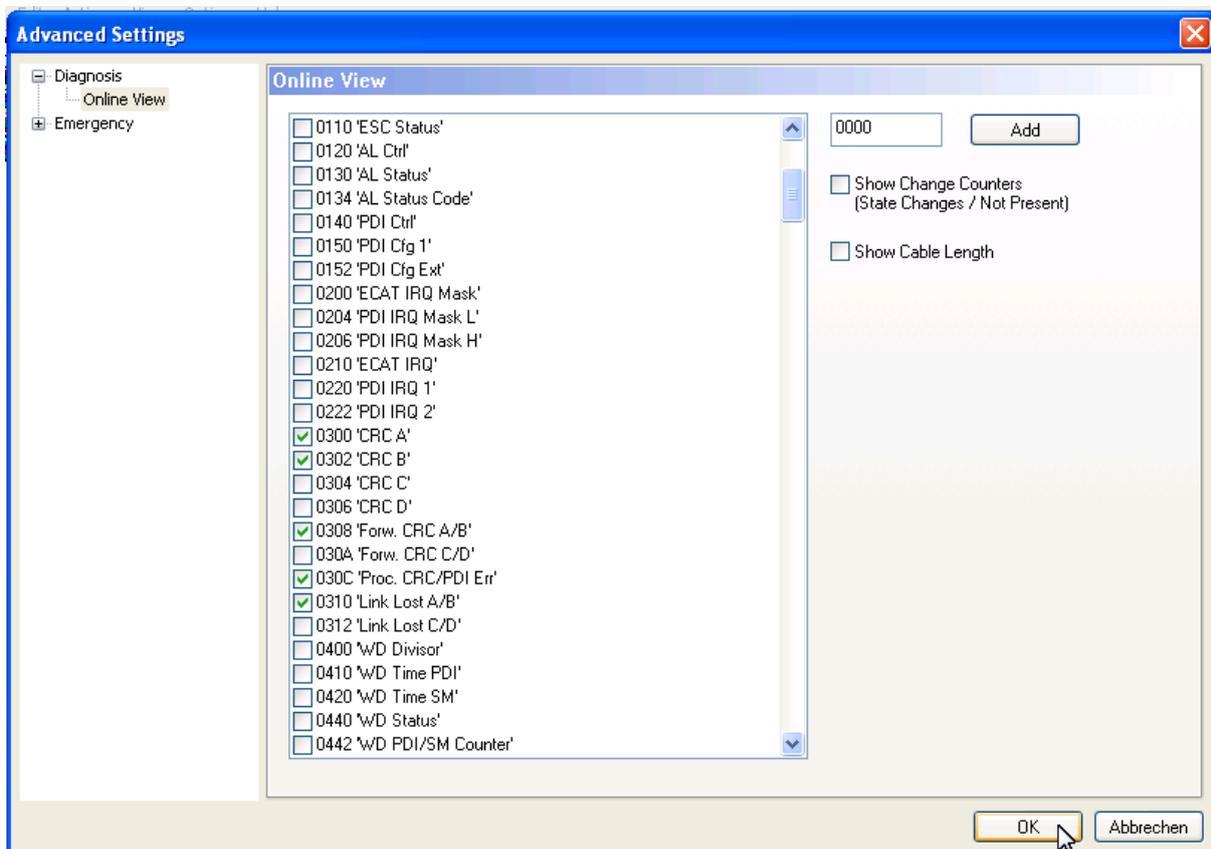
Figure 22: Select registers for online view

5. Select the following registers for online viewing, and press OK:

- "0000 ESC Rev./Type" and
 - "0002 ESC Build"
- to identify the type of ESC.

NOTE: TwinCAT uses A/B/C/D to enumerate the ESC ports 0/1/2/3.

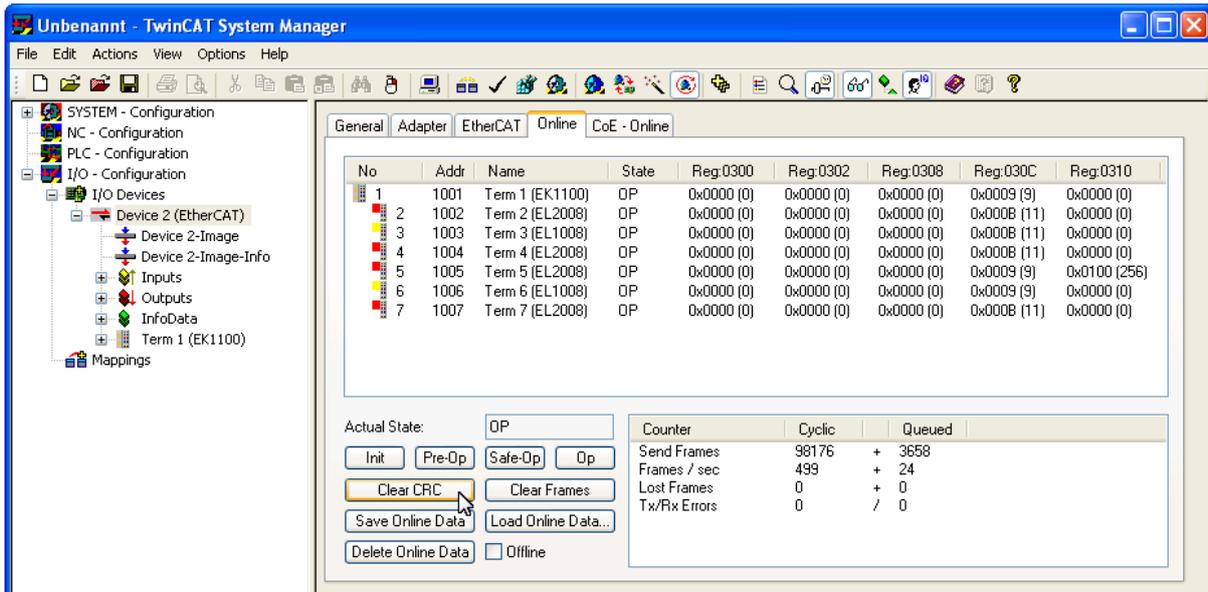
Figure 23: Some power-up errors without significance

- Now you might see some errors in registers 0x030C-0x0313 resulting from power-up. These errors have no significance, only errors increasing during operation are important. TwinCAT reads out and clears only the error counters in register 0x0300-0x0307, and pressing the button “Clear CRC” also clears only these counters. The other counters are still accumulating from power-up until now. Please note that the error counters are shown as 16 bit values, i.e., the column called “Reg. 0300” shows in fact registers 0x0300 (lower 8 bit, right side) and 0x0301 (higher 8 bit, left side).

Press the buttons “Clear CRC” and “Clear Frames” to clear the TwinCAT counters in the lower right area (Lost frames, Tx/Rx Errors).

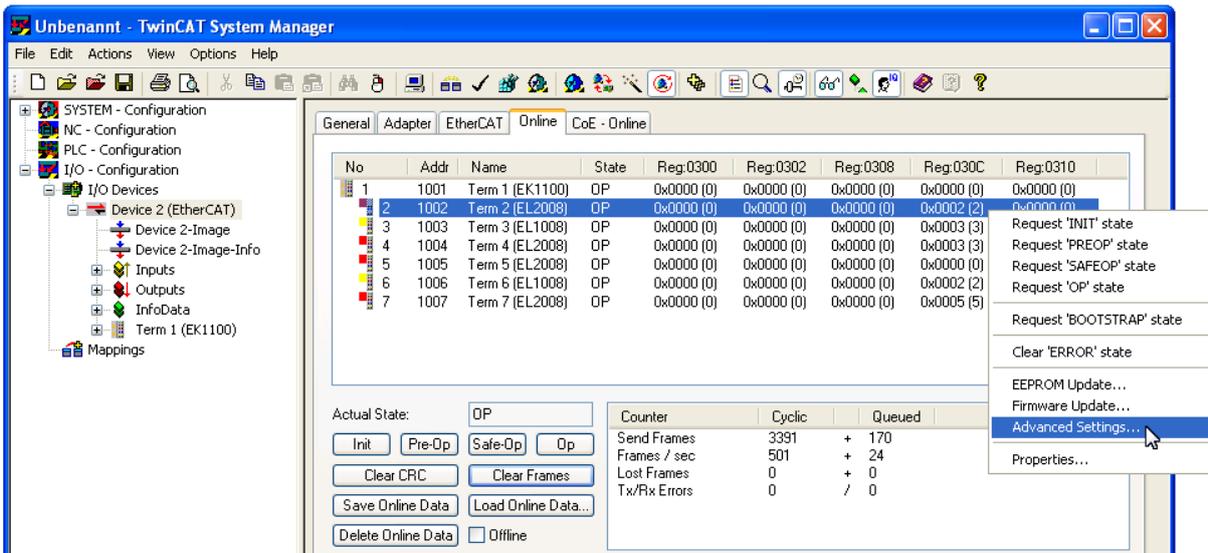
Figure 24: Clear error counters manually in the advanced settings

- If TwinCAT does not clear all the error counters (older versions), follow these steps for each ESC: At first, highlight the ESC with the error counters you want to clear. Right-click into the row and select “Advanced Settings...” from the context menu.

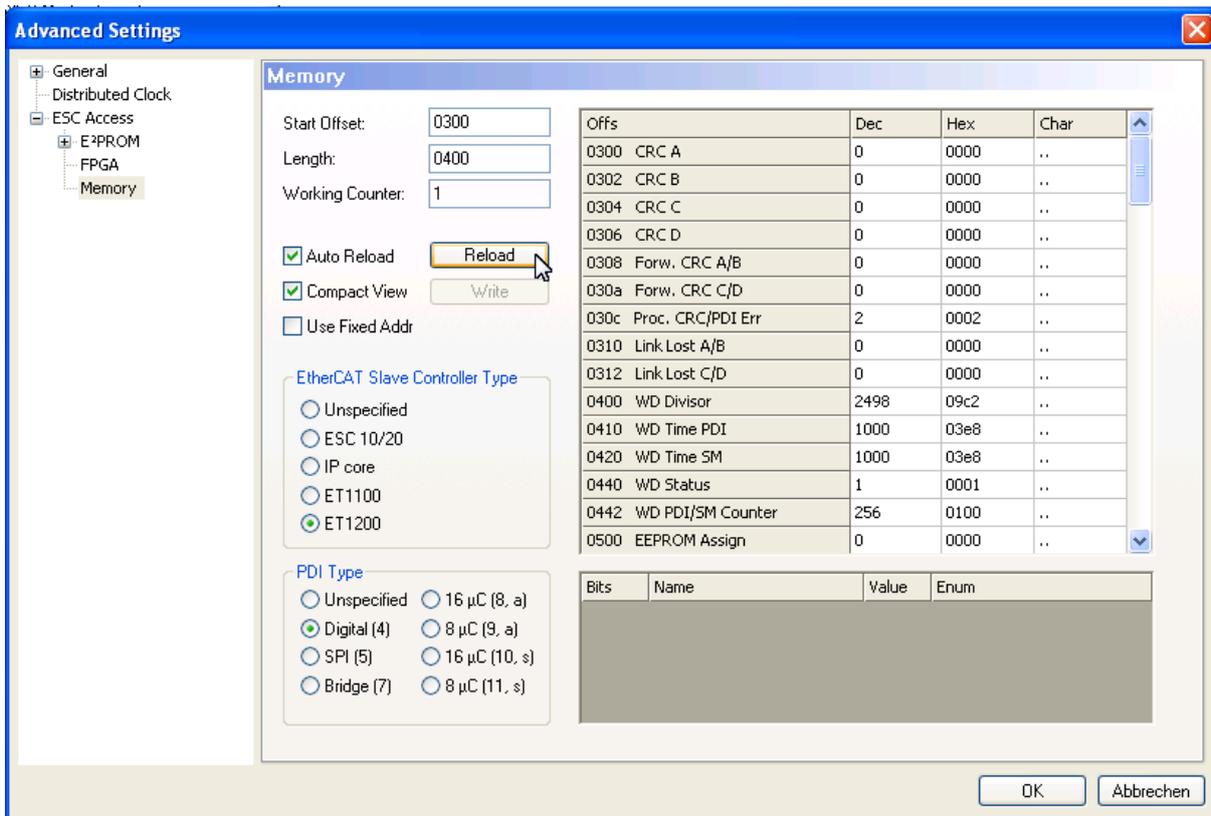
Figure 25: Error counters in the Advanced Settings window

- Enter “Start Offset” of 300, activate “Auto Reload” and “Compact view”. Press the “Reload” button to see the error counters from 0x0300 ff. The error counters are again shown as 16 bit values.

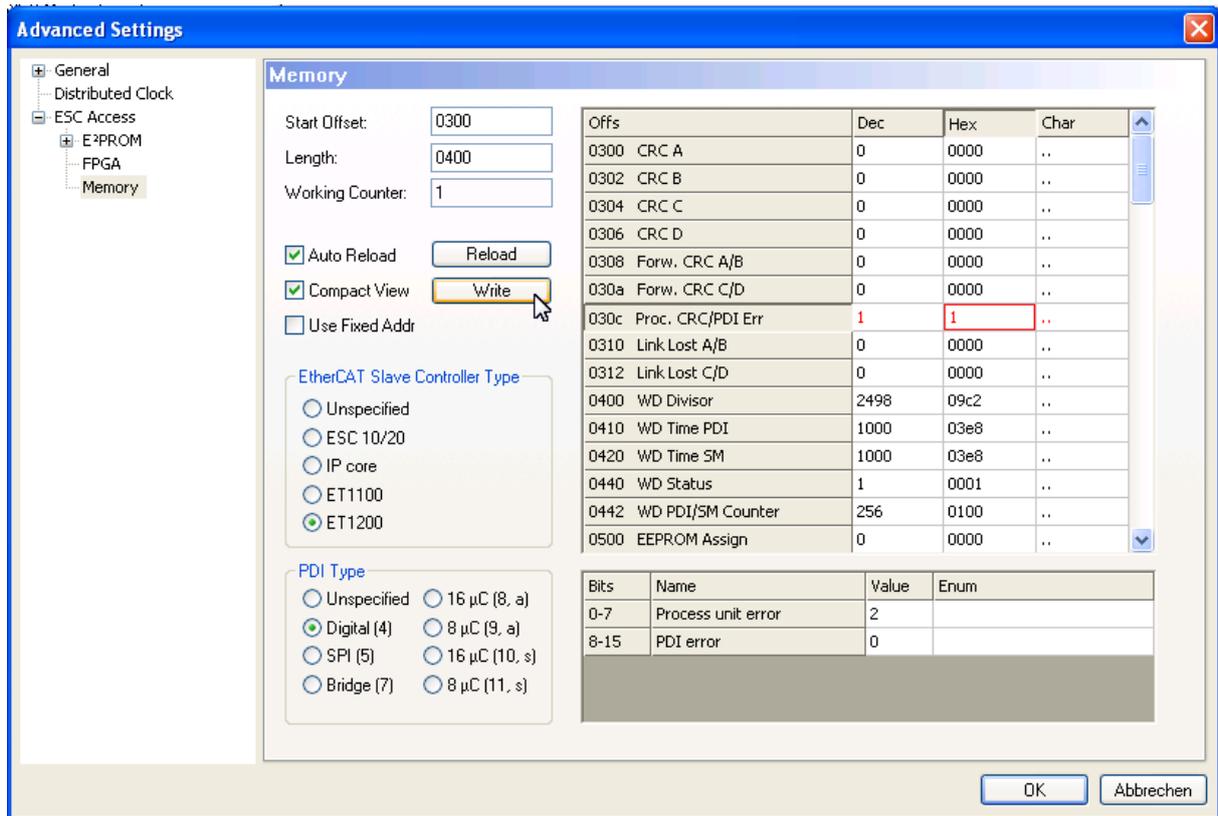
Figure 27: Write to the error counter to clear it

10. Press the “Write” button to write the new value, which in fact clears the error counter.

- To clear an error counter, write any value into it, it is the write access and not the value which clears the error counter. Refer to the ESC data sheet section II to find out which error counters are cleared in a group.
